## Copper Nickel Solutions

### Coating for chiller strainer in the tropics

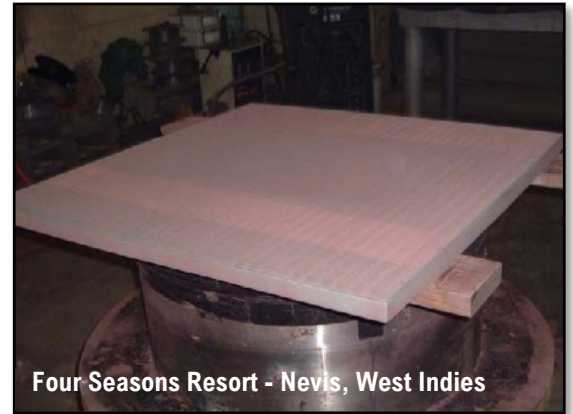
Four Seasons Resort - Nevis, West Indies

The Four Seasons, an island resort in the West Indies, struggled with bio-fouling on their intake equipment. Elgin worked with the resort owner to retrofit his existing intake system (an offshore strainer) with a new passive screen system. Elgin also worked with the site owner to develop a custom flow modifier within the system, which ensured consistent flow, and adjusted the screens for easier installation and removal. Finally, Elgin's copper nickel coating solved the bio-fouling problems.

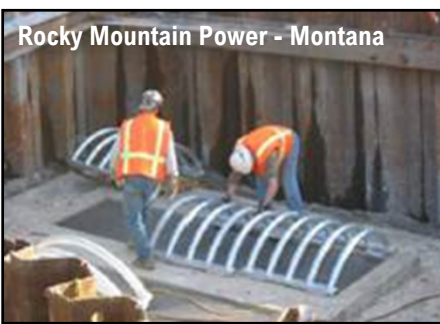
Rocky Mountain Power - Montana

### Coating for flat panel screens at hydro plant

A small hydroelectric plant in Montana was inundated with bio-fouling problems. To protect their system, they retrofitted their existing structure with an array of flat panels coated with Elgin's copper nickel coating. Our solution simply worked.

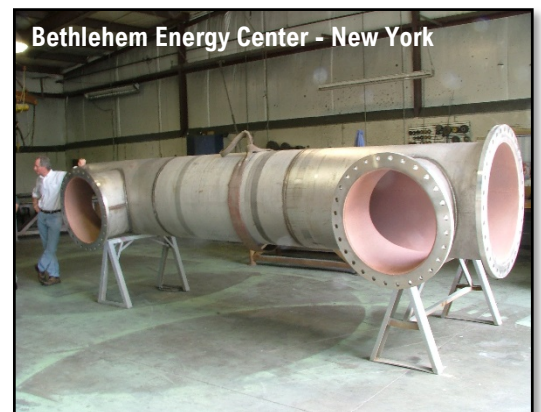
Bethlehem Energy Center - New York

### Coating for intake pipe at power plant

A power plant retrofitted its cooling water intake system to comply with EPA Regulation 316(b). Concerns arose because the water body was infested with zebra mussels. In addition, the flow rate through the system was going to be decreased to a flow rate optimal for zebra mussel growth. The facility needed to maintain ample cooling water to avoid costly thermal discharge penalties or a system outage. Elgin's copper nickel coating was used to address these concerns. Our team built the pipe manifold and applied coating to the ID of the assembly. This application led to a significant reduction in capital cost compared to copper nickel construction.
