COOK LEGACY CASE STUDY

San Marcos Drum Intake & AirBurst System

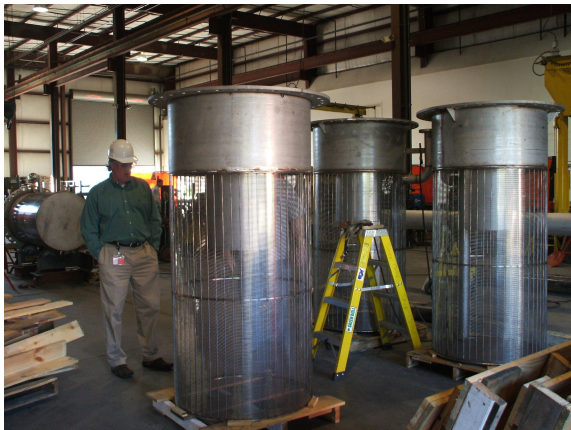
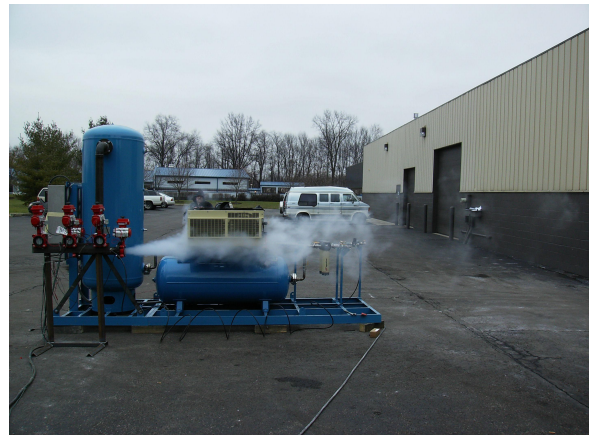
Industry	Municipal Water
Problem	The system was a suite of drum screens which were directly connected to a series of pumps. This created a control system integration challenge to coordinate the pump and the airburst screen cleaning system. Additionally, the screens had to be retrofit to an existing site where there was limited physical space for the screens.
Solution	Cook Legacy developed a custom AirBurst system with adjustable operating cycles to coordinate with the operating strategy of the plant. The site conditions required the use of a custom screen geometry. This was accomplished by use of a purpose built flow modifier to maintain velocity balance across the screen.
Result	The screens have been in successful operation for five years. Because of the flow balanced screens the operators have been able to lower the operating cycle of the airburst as the screens are not clogging.
