**ELGIN SEPARATION SOLUTIONS CASE STUDY**

**Majer, Iraq Water Treatment Plant**

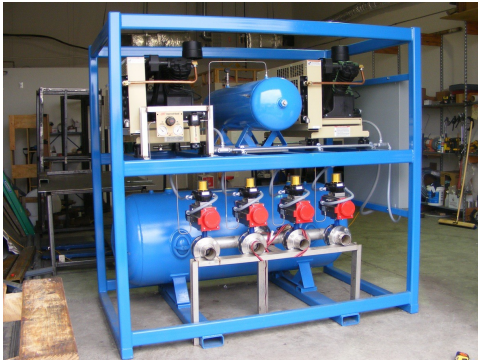
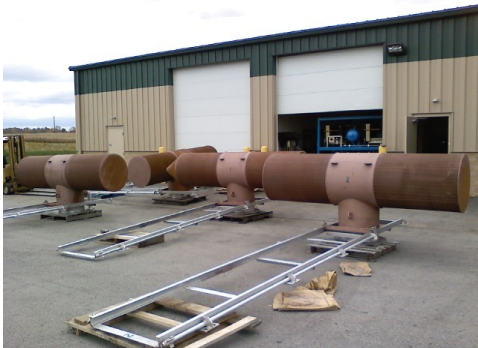
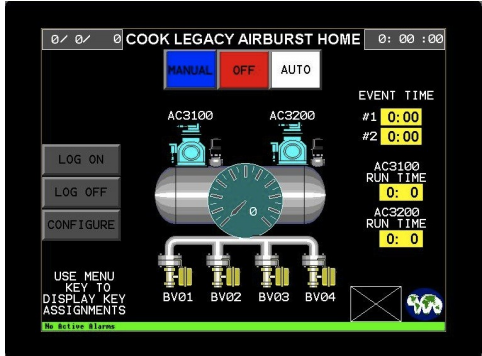
Soon water from the Tigris River will flow through screens designed and built by Elgin. We provided an Intake and AirBurst System for installation at a water treatment plant in Iraq. The ancient waterway is also rife with biofouling problems. In response, Elgin built four screens with its proprietary Jacquelyn Coating™. The system also had to be durable enough to stand up to Iraq's harsh environment.

To address the language barrier Elgin modified our RAMA™ control system to make a panel that was operable based only on pictures and numbers. With our RAMA™ control software and third-party graphically based touch panel, we minimized any translation errors. We designed unique interactive screens, like the one shown below, on which pictures represented a part or function in the system. For instance, if an operator presses a valve icon, that accesses the valve control page.
